Watch Out *for* Escape

By FCC (SW) Barry G. Hardman

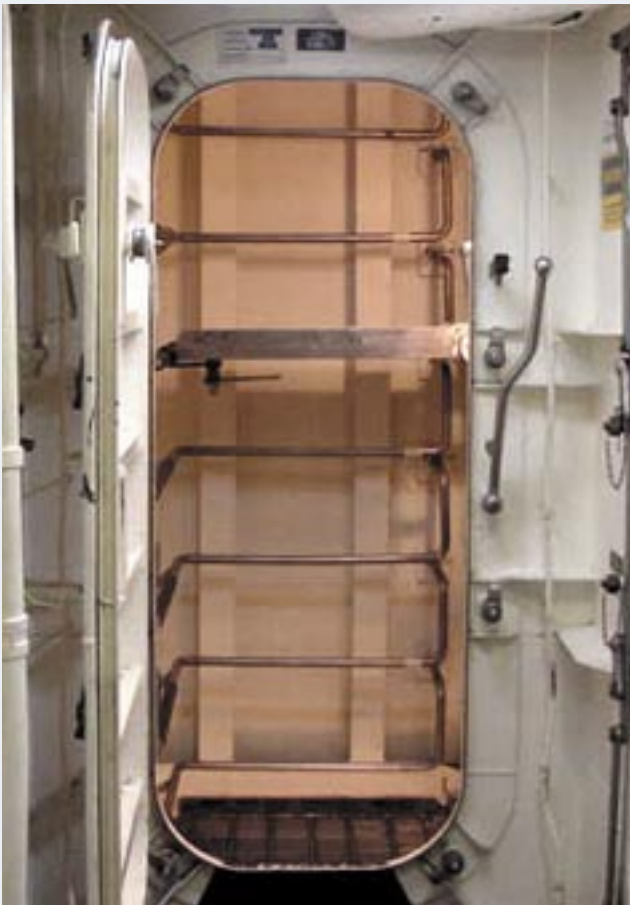
This is the “guilty” quick-acting water-tight door: The mishap victim stepped through it to return to his space and fell four decks. The grating is shown in its normal down position.

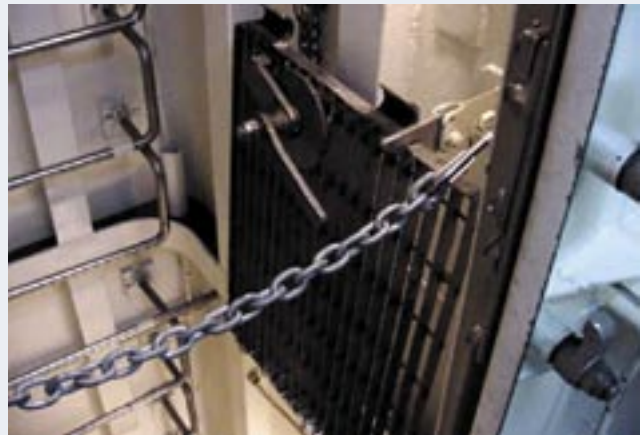
The grating is shown in its up position, as it was left following the drill. It should have been returned to its down position

Second, safety-related equipment always must be returned to the primary position for which it was designed. The hinged gratings were installed to offer easy passage across the escape trunk and were meant to be left in the down position. However, the hinged design enabled them to be folded up to provide unimpeded escape up the trunk from MER 2. The fire party's failure to properly re-stow, or put down, the grating created the unsafe condition that led to a shipmate's injuries.

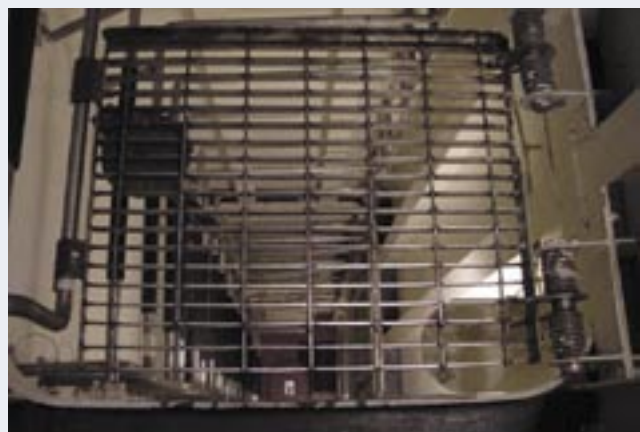
This is the grating’s normal position. Unfortunately, it wasn’t returned to this position when the fire party left the space after GQ had ended.

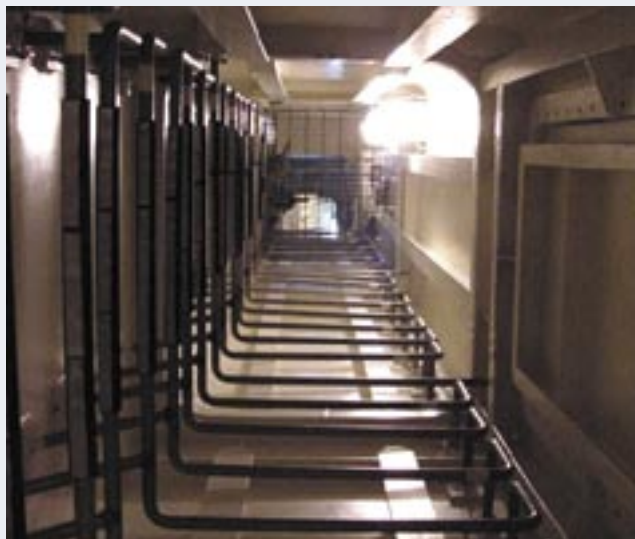
Looking up from where the mishap victim landed, one can easily see how far he fell. The grating—in its down position—is visible.

trunk and stepped in, expecting to set foot on the safety grating. He either forgot (or maybe hadn't noticed when exiting the trunk to make his report to central control) that the grating was up, and he fell four decks (30 feet) down the trunk.

Fortunately, the Sailor never hit a bulkhead or any other obstructions during his fall and was able to land on his feet. Though this landing probably saved his life, his injuries were severe: fractures to his right heel, left ankle, right foot and lumbar spine. He became a permanent loss to his command and is on limited duty.

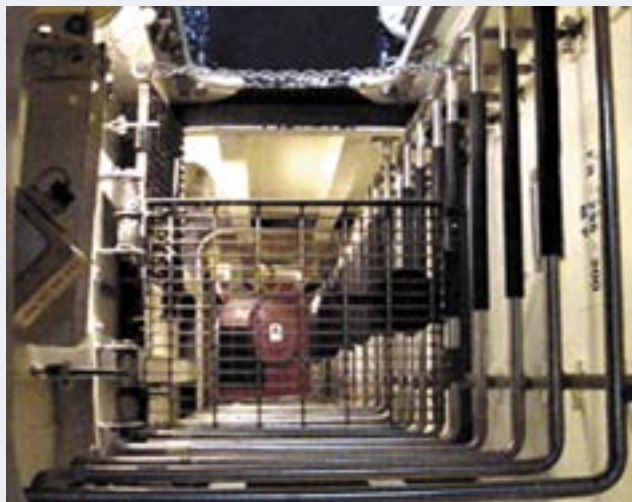
This is looking down from the door through which the mishap victim stepped and fell (the lower half of the door opening is visible in the top of the photograph).
